Eco-Teens TALBOT-NORFOLK TRIANGLE Walk Audit Report

August 2015

Eco-Teens TNT Walk Audit Report

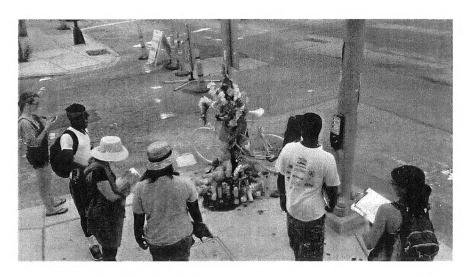
Eco-Teens Assessing Talbot-New England Ave Intersection Site of Bicycle Fatality

Also note faded crosswalks. Pedestrians need more WALK time to cross Talbot.

- Better crossing conditions, at least 20 seconds to cross with the WALK at Talbot and New England Avenue.
- Trash bins

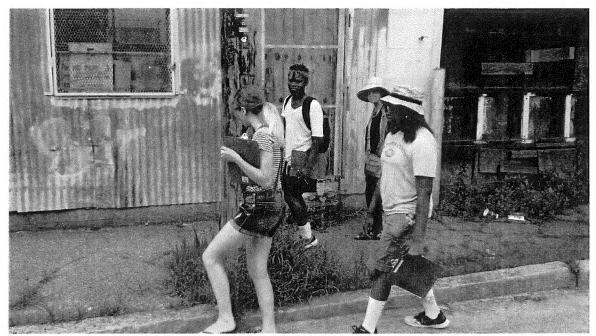
On New England Ave., the sidewalks are broken to the point that it is a safety issue. There are also no public trashcans and that has resulted in New England Ave. being covered in garbage. See photo below. It would be extremely helpful to get public trashcans on New England Ave. now and to have the sidewalks repaired.

Eco Teens survey the overgrown sidewalks on New England Ave.

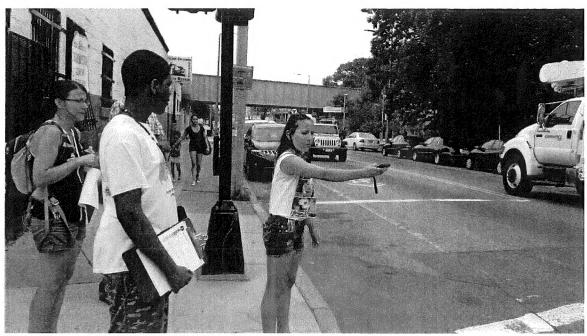
Eco-Teen Measures Traffic Speeds on Talbot Ave. Speeds on Talbot ranged from 20 – 40 mph.
